# SECTION 3

# TROUBLESHOOTING

**SERVICE AND MAINTENANCE**

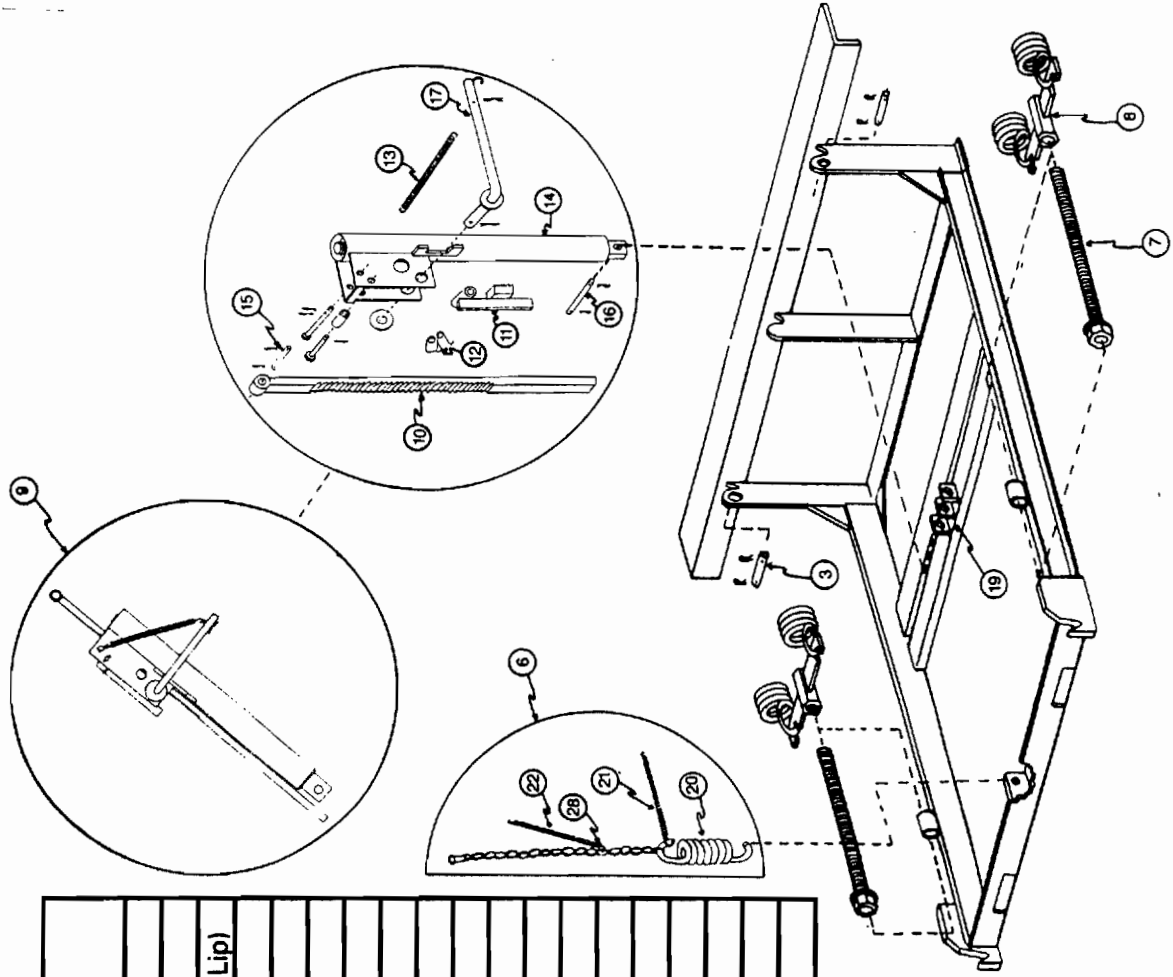
PARTS LIST	
ITEM	DESCRIPTION
3	DECK REAR HINGE KIT (SET)
6	SNUBBING CHAIN ASSEMBLY (For standard 16" Lip)
7	ADJUSTING ROD ASSEMBLY
8	WING NUT ASSEMBLY
9	RATCHET ASSEMBLY
10	UPPER BAR
11	PAWL
12	PAWL SPRING
13	RELEASE LEVER SPRING
14	RATCHET HOUSING
15	UPPER PIN KIT
16	LOWER PIN KIT
17	RELEASE LEVER ARM
19	RATCHET MOUNTING ASSEMBLY LOWER
20	SNUBBING SPRING
21	SNUBBER CHAIN TENSION SPRING
22	LIP LOCK SPRING
28	"S" HOOK

NOTE: REFERENCE ITEM NUMBERS LISTED BELOW ON PAGES 3-3 AND 3-4.

SYMPTOM:	PROBABLE CAUSE:	CORRECTION:
<p>WHEN RELEASE RING IS PULLED, DECK RAISES BUT LIP DOES NOT FULLY EXTEND AND LOCK.</p> <p>Note: With Hydra-Lip Option, lip is designed to begin closing once extended, or when truck departs. No adjustment is required. Assem. # 30</p>	<p>1. Improper main spring adjustment.</p>	<p>Tighten both main spring adjustment nuts one or two rotation clockwise and re-test. Item #7 (1 1/2" socket or wrench)</p>
	<p>2. Lip lock spring is stretched.</p>	<p>Replace spring or lower spring one or two links in snubber chain. Item # 22; Assem. # 6</p>
	<p>3. Improper adjustment of lip assist spring (furnished as standard equipment with 18" and 20" lip lengths)</p>	<p>Tighten both hex nuts on the lip assist rods two (2) clockwise rotations and re-test. Item # 27.</p>
	<p>4. Lip lock spring is broken or disconnected.</p>	<p>Replace broken spring and/or reconnect spring to proper chain link with "S" hook. Item # 22, Assem. # 6</p>
